KEY POINTS

Technical Information Bulletin

« hexavalent chromium has been detected in certain
Caterpillar engines »

1/ Introduction: Cr-6 presence on engines

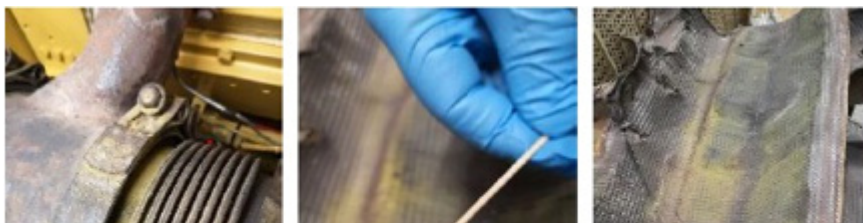
Cr-6 is usually present as solid, non-volatile yellow powder that clumps on exhaust manifolds.

It is a product of a chemical reaction that occurs during operation of the engine. It is not initially present on the new engines.

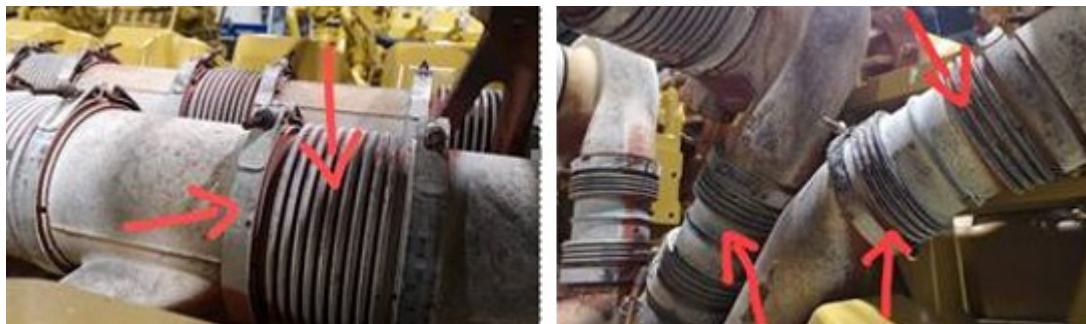
exhaust manifold screws (nut/bolt), on thermal insulation inner face and on turbocharger.

When ENERIA team carry out maintenance on exhaust manifolds, the following clean-up process is implemented:

- Wear «Cr-6 specific» Personal Protective Equipment (full single use protection suit, eyes protection, mask and gloves),
- Remove thermal insulation if present,
- Test the presence of Cr-6 with the detection swab test Kit,
- If the test is negative, the technical staff is no longer required to wear « Cr-6 specific » Personal Protective Equipment for the rest of the procedure,
- If the test is positive, technical staff must keep the « Cr-6 specific » Personal Protective Equipment listed above, while cleaning the contaminated parts. The HSE cleaning procedure of 26/11/19 includes:
 - Clean the fixed parts with a dampened clean cloth,
 - Use Branch washing machine for removable parts cleaning,
 - Collect, store and dispose the contaminated wastes.

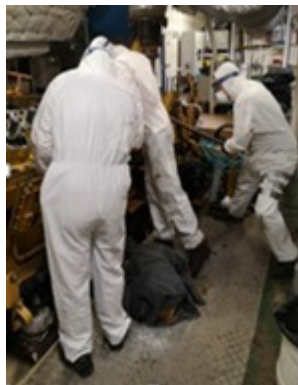
In case of direct operation on the exhaust manifolds there is a potential risk of contact with deposits or inhalation. Thus, the recommended personal protection measures are following:

- Full single-use protective suit,
- Nitrile protective gloves, if necessary doubled with other protective gloves,
- Waterproof eyes protection,
- FFP2 or FFP3 type Respiratory protection (single-use masks).
